Manhole Inspection Summary

Manhole # S39CC_016MH

Insp Date: **8/20/08 9:47 AM**

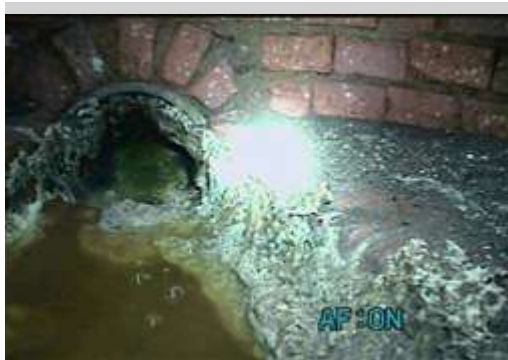
Defect 3

Condition: ☐ Sound ☐ Cracked ☐ Root Intrusion ☐ Deteriorated ☐ Leaks ☒ **Debris**

channel debris/build up

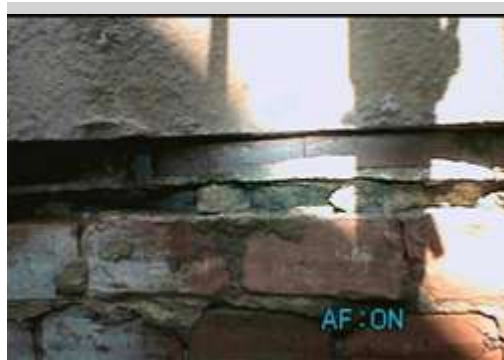
Defect 2

Condition: ☐ Sound ☒ **Cracked** ☐ Root Intrusion ☒ **Loose Brick** ☒ **Deteriorated**

Chimney cracked, loose bricks,
deteriorating, frame adj

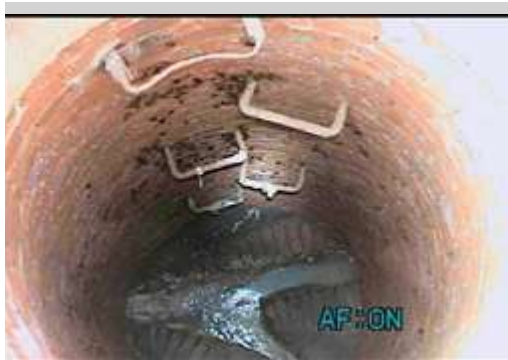
Defect 1

Count: **5** Missing: **0** ☒ **Corroded**

☒ **Evidence Of Surcharge** Depth: **6** (ft.) ☐ Active Surcharge Present

corroded steps, surcharge evidence

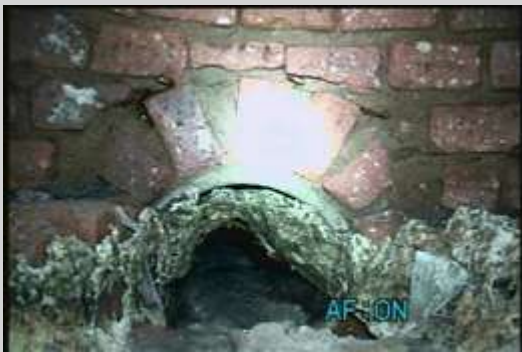
12 O'Clock Outflow

Deposits: ☐ None ☐ Mud ☒ **Sludge** ☐ Debris ☐ Grease

Silt Depth: 4 (in.) Deposits Extent: **Medium**
